# AGT 1500 Erosion / Corrosion Coating

*Kevin Kauth  
TARDEC - GVPM  
29 July 2014*

# Sand Ingestion Lab Test

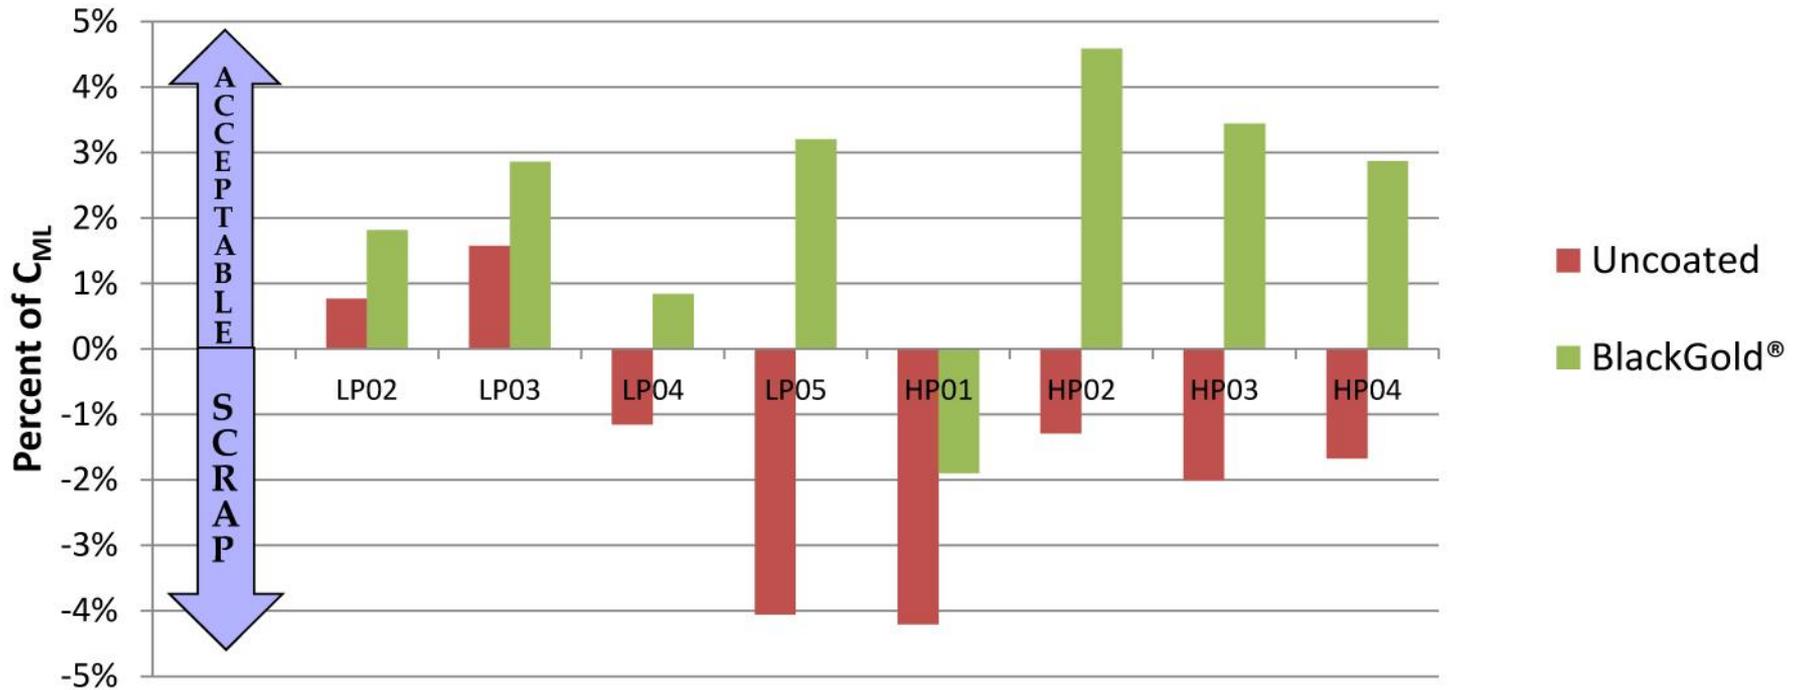
## Chord Loss

After 9.5 lbm Sand Ingested

**BlackGold® v4 coating delayed parts from reaching Chord Maintenance Limits**

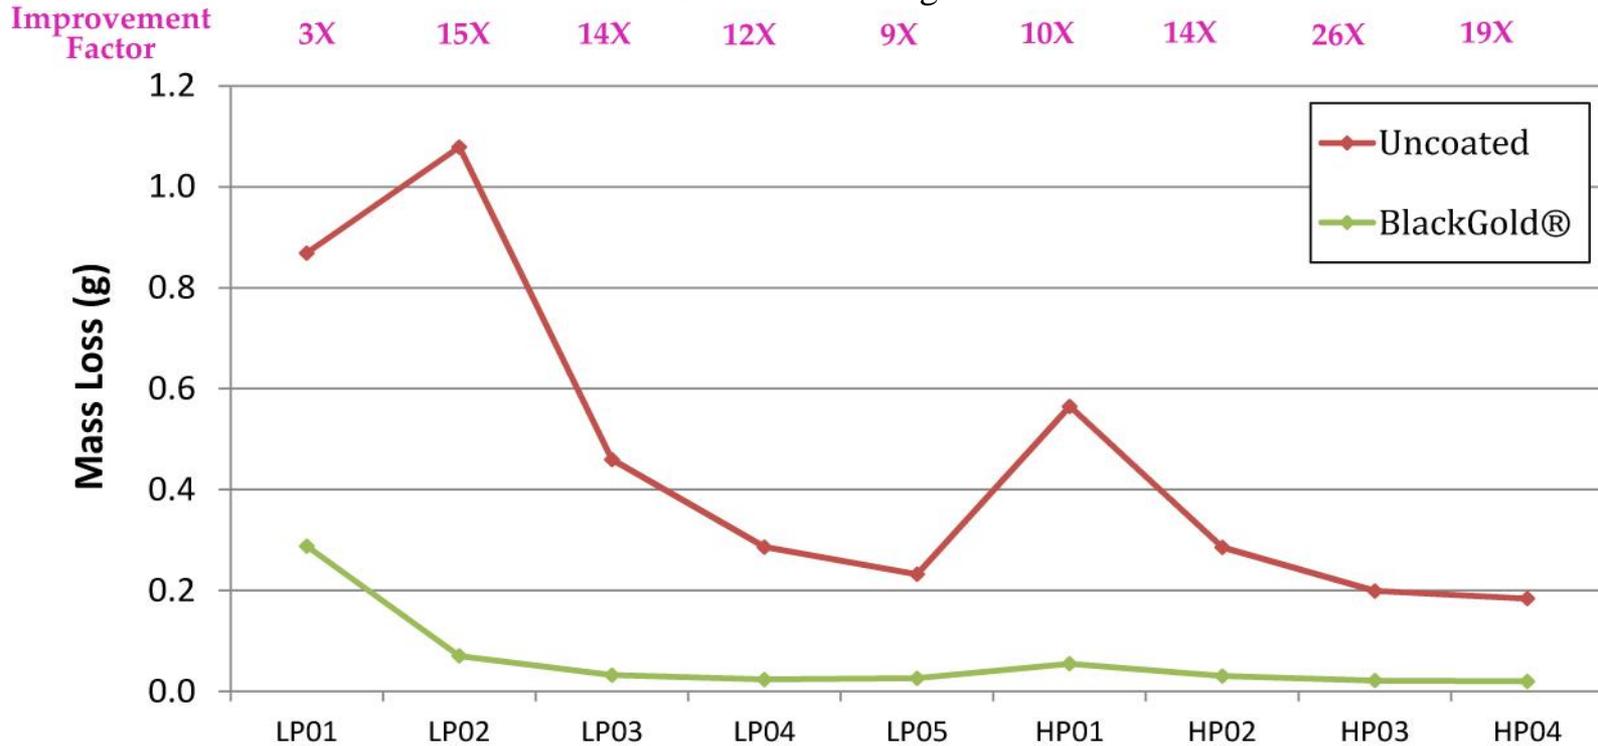
## Mass Loss

After 9.5 lbm Sand Ingested

**BlackGold® v4 coating significantly reduces part mass loss**

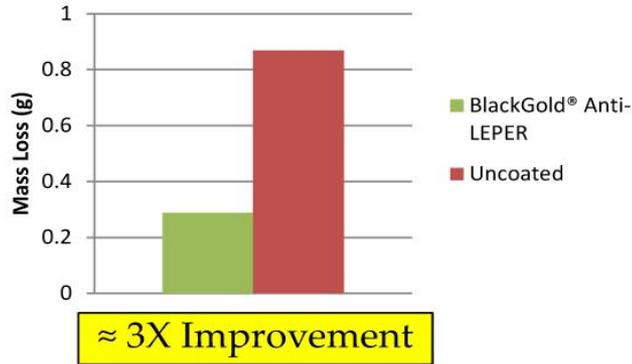
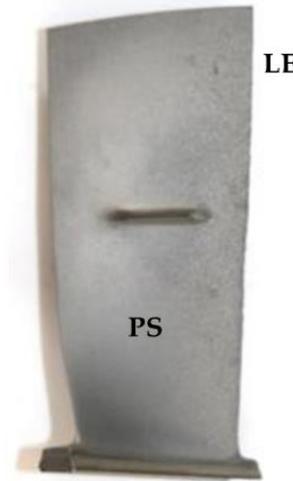
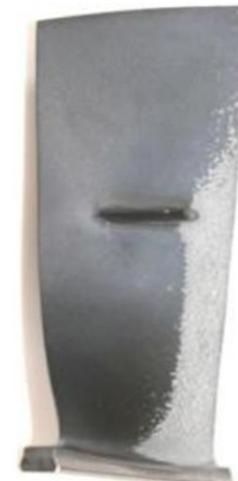
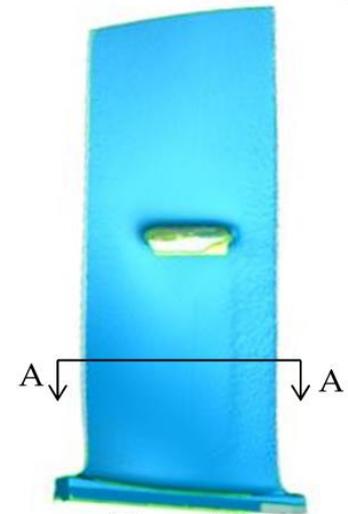
# Results – LP01 Mass Loss

Mass loss after 15.75 lbm  
Images & Scan after 15.75 lbm

Note: Both uncoated and coated exhibited LE roughness not allowed per NMWR 9-2835-255-2

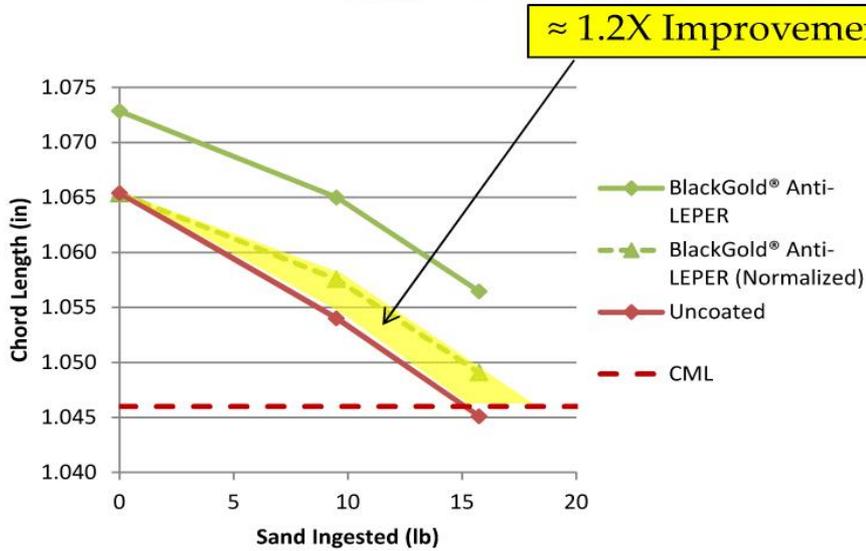
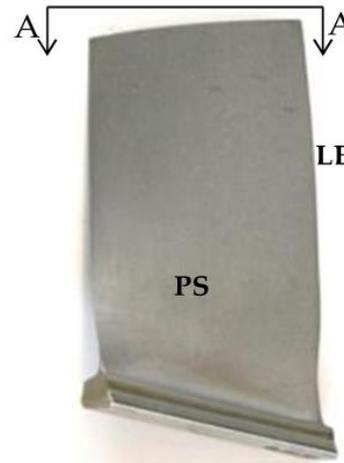
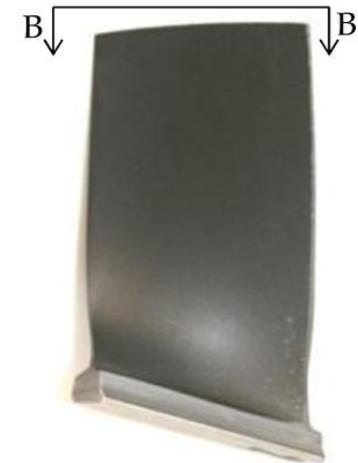
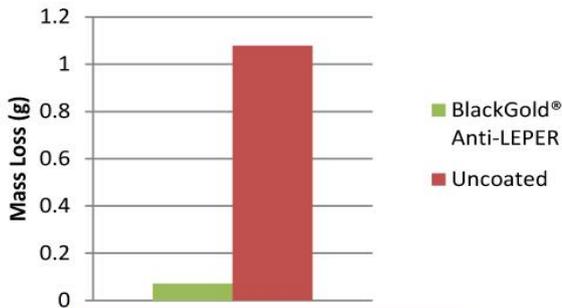
# Results – LP02 Chord Loss

Mass loss after 15.75 lbm  
Images after 15.75 lbm

**≈ 15X Improvement**

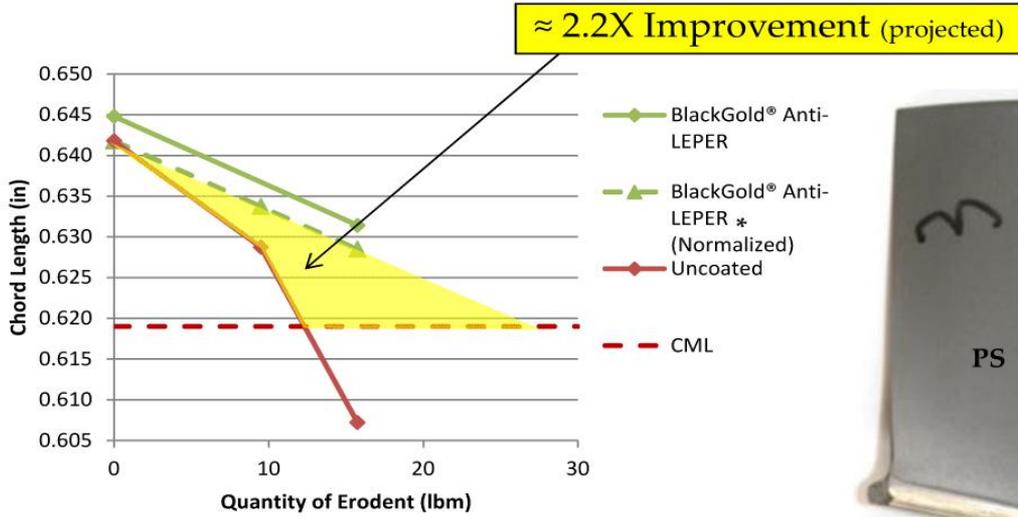
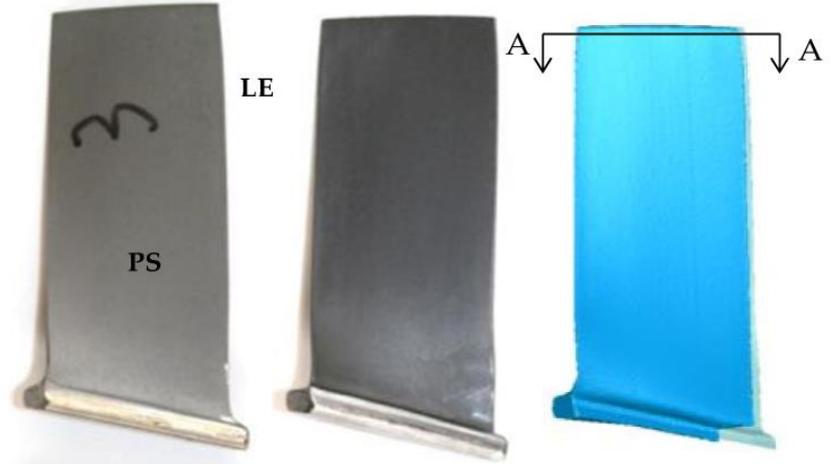
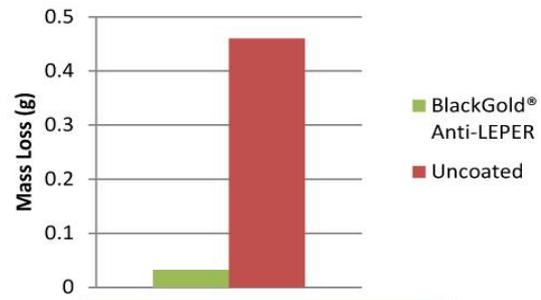
# Results – LP03 Chord Loss

Mass loss after 15.75 lbm  
Images & Scan after 15.75 lbm

**≈ 14X Improvement**

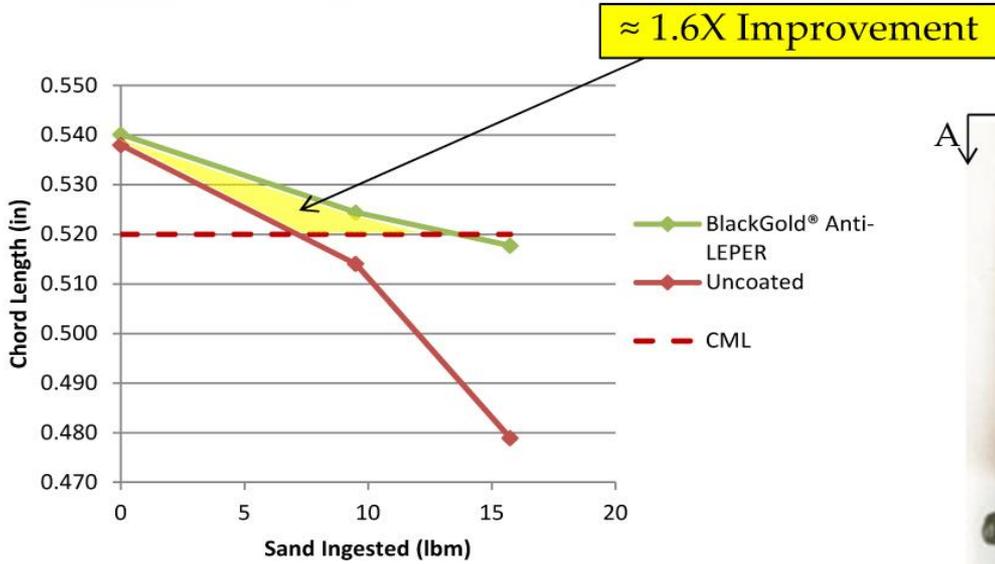
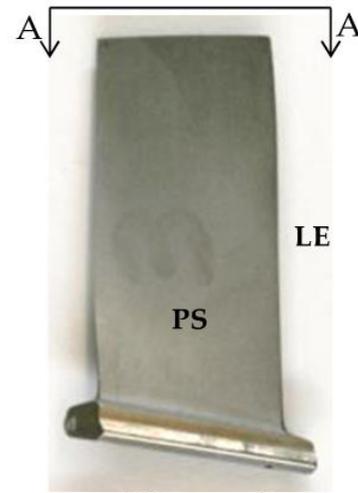
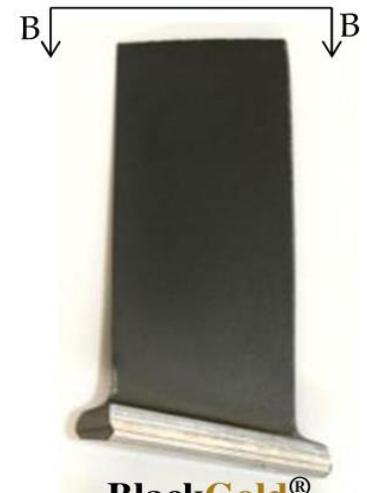
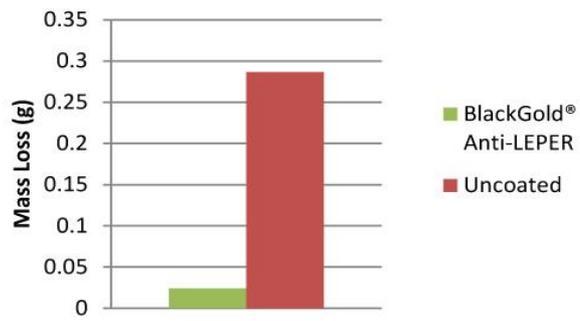
# Results – LP04 Chord Loss

Mass loss after 15.75 lbm  
Images after 15.75 lbm

**≈ 12X Improvement**

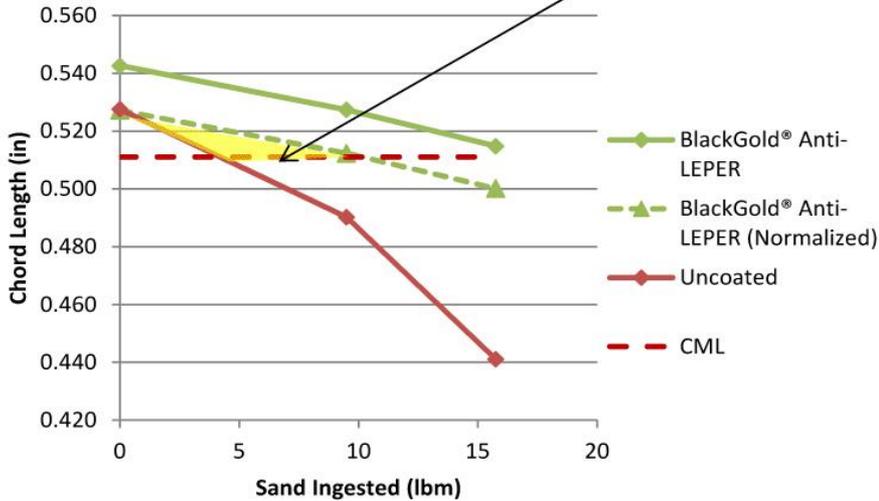
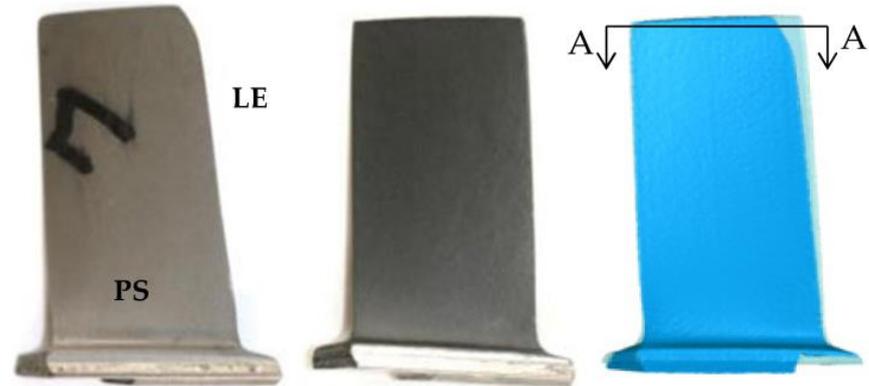
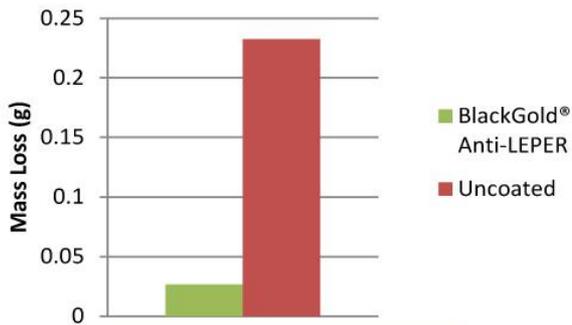
# Results – LP05 Chord Loss

≈ 2.4X Improvement

Mass loss after 15.75 lbm  
Images & Scan after 15.75 lbm

≈ 9X Improvement

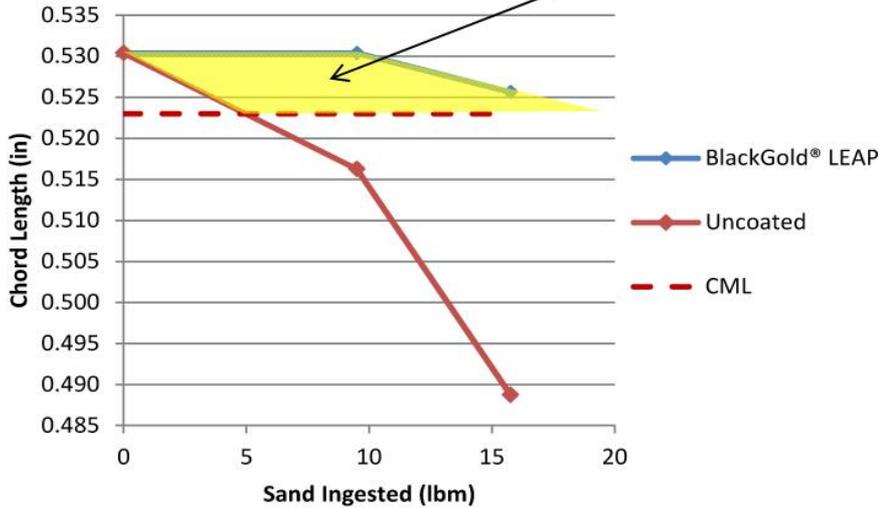
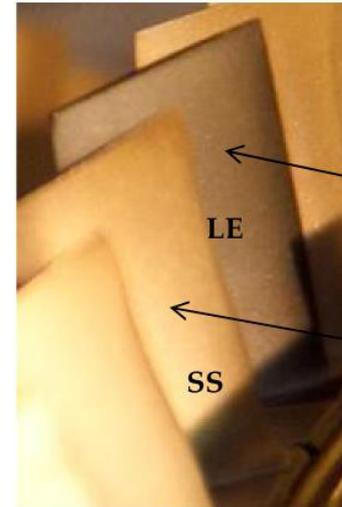
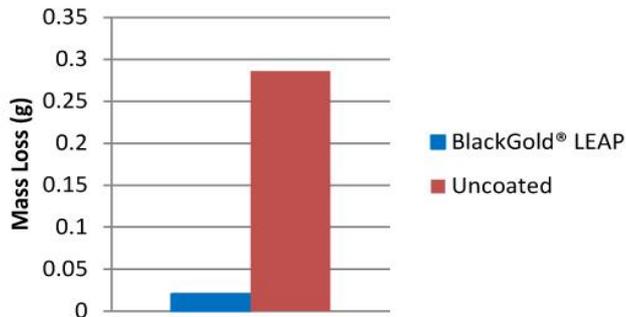
≈ 3.9X Improvement (projected)

Mass loss after 15.75 lbm  
Images after 9.5 lbm

No LEPER observed at 9.5lbm

≈ 14X Improvement

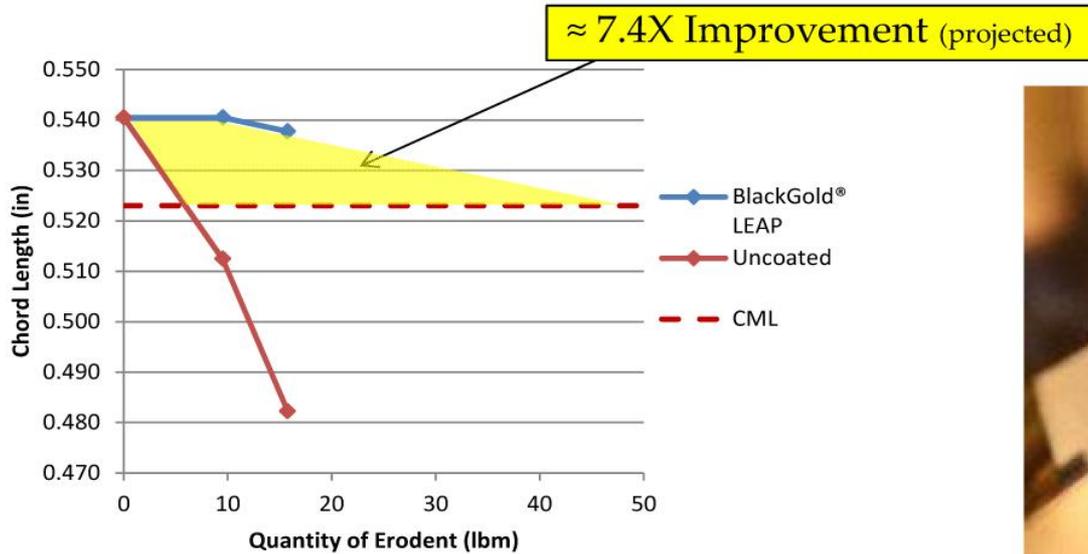
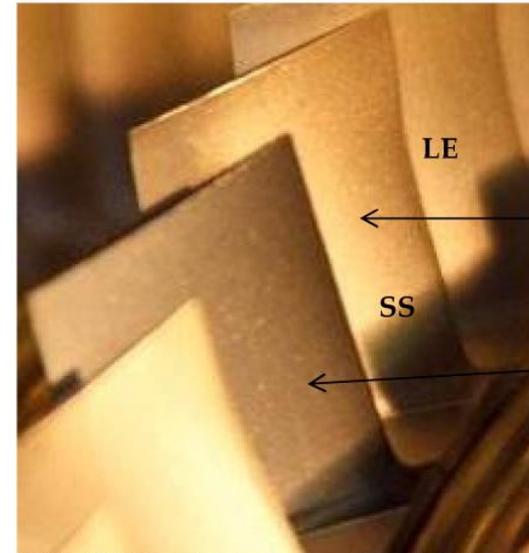
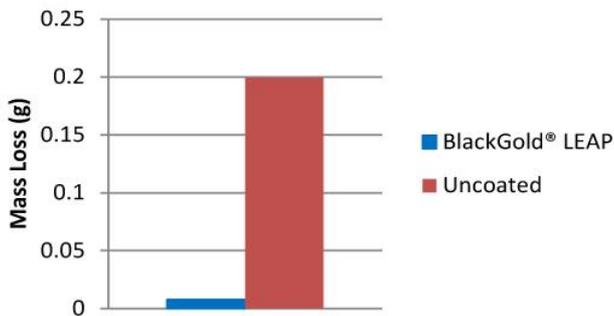
# Results – HP03 Chord Loss

Mass loss after 15.75 lbm  
Image after 9.5 lbm  
Top view after 15.75 lbm

No LEPER observed at 9.5lbm

**≈ 26X Improvement**

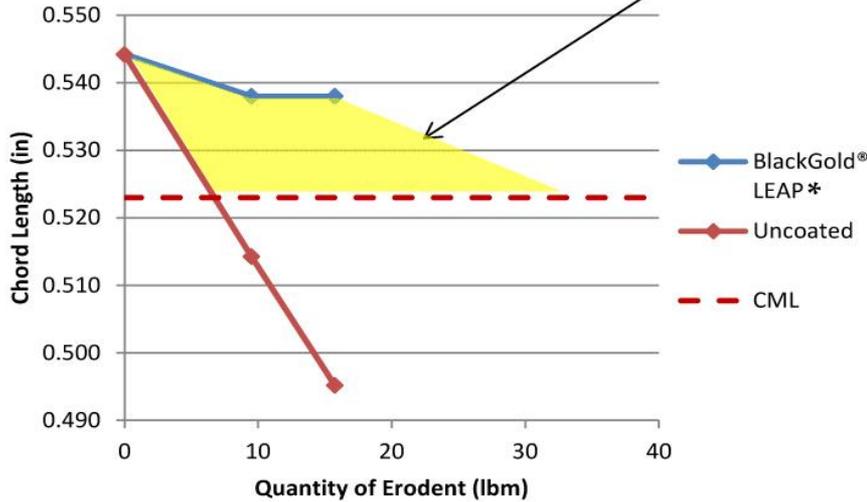
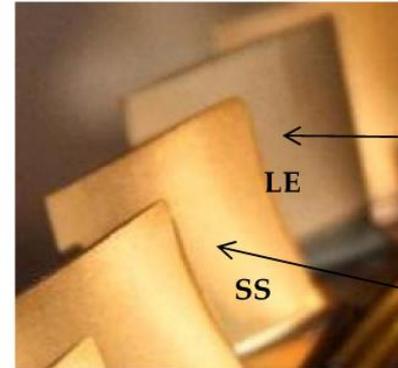
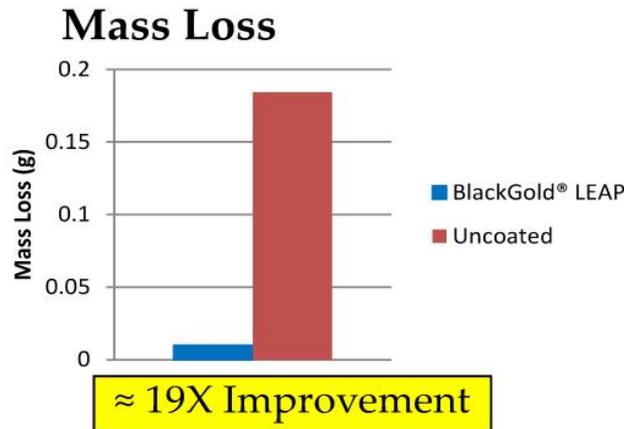
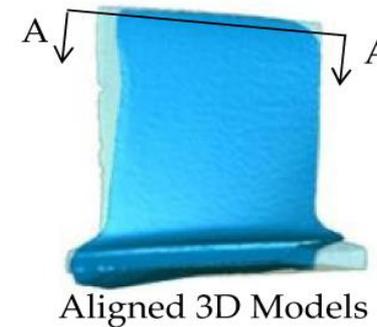
# Results – HP04 Chord Loss

≈ 4.8X Improvement (projected)

Mass loss after 15.75 lbm  
Image after 9.5 lbm  
Scan after 15.75 lbm

No LEPER observed at 9.5 lbm

≈ 19X Improvement

\*Extrapolated using slope between 0 lbm and 9.5 lbm

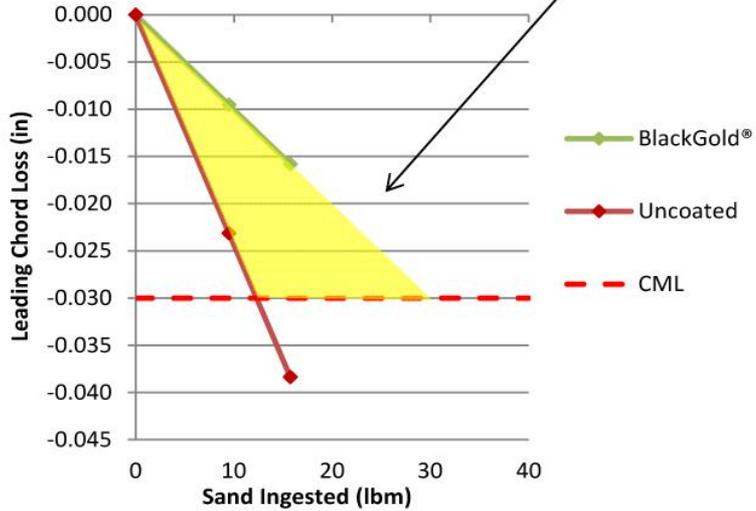
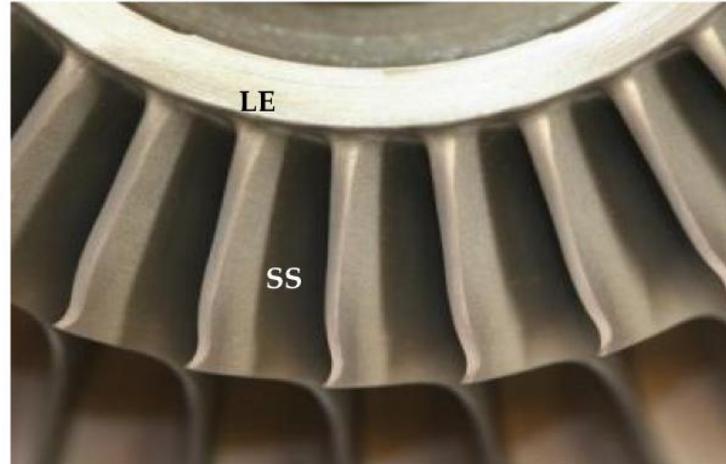
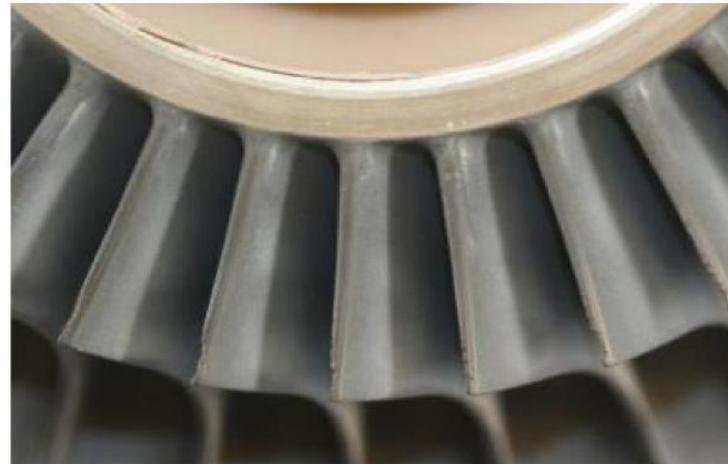
# Impeller Chord Loss

Images after 15.75lbm

≈ 2.4X Improvement (projected)

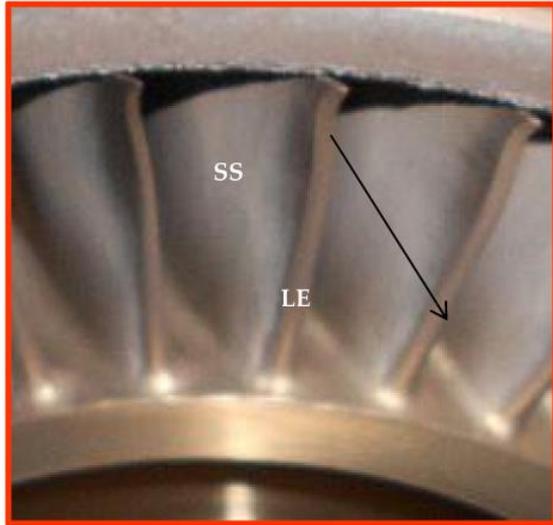
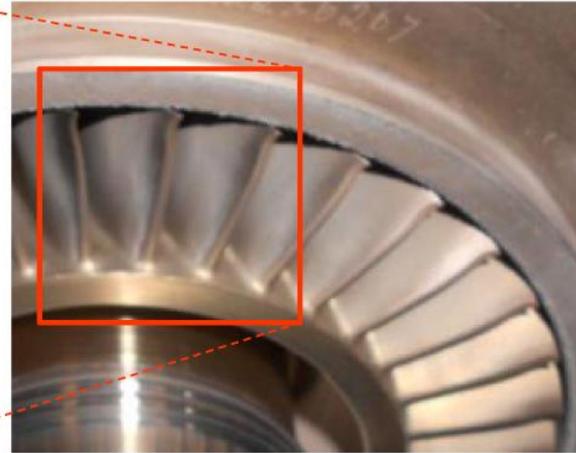
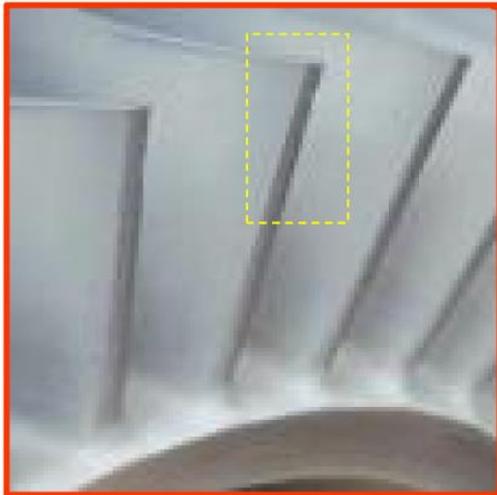
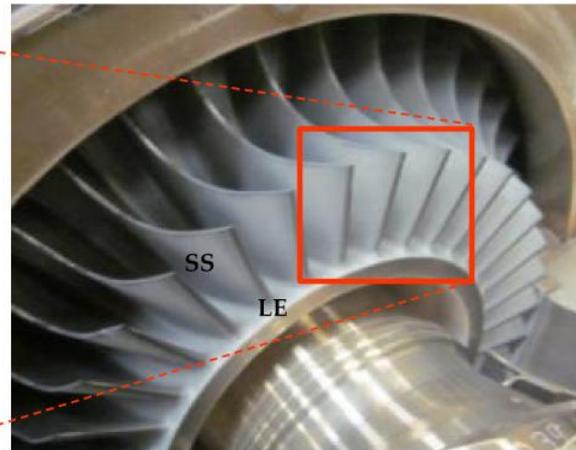
# Impeller

**Uncoated**  
9.5 lbm  
( $\approx 0.93$  lbm/hr)

**BlackGold<sup>®</sup>**  
6.75 lbm  
( $\approx 1.41$  lbm/hr)

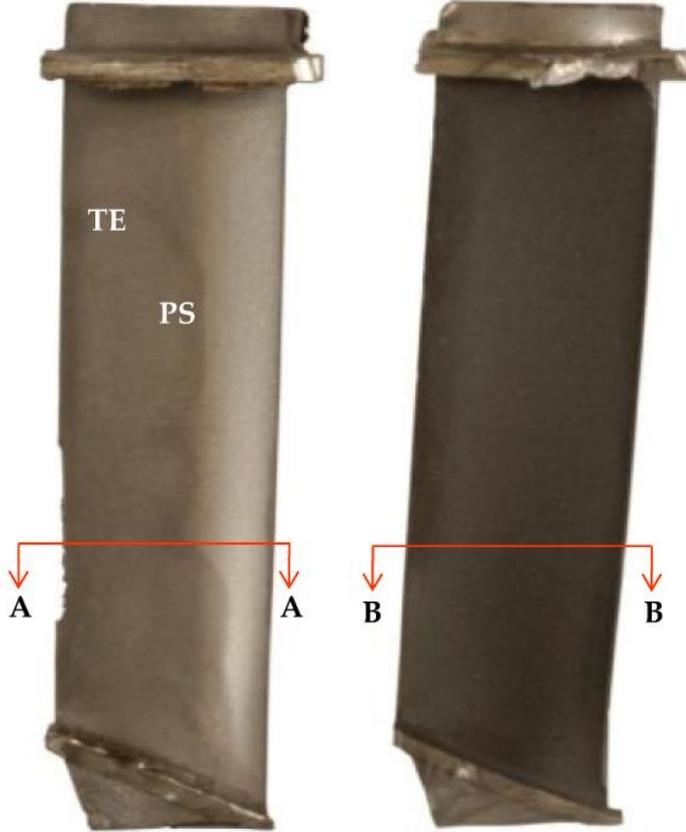
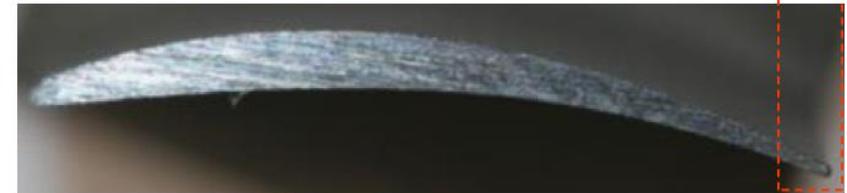
# LP02 Stator Vane

TE Thinning

Maintains Trailing Edge thickness
