USCG Aviation Composite “ Bonded Material Testing”

Rusty Waldrop NDI Program Manager USCG
rusty.g.waldrop@uscg.mil

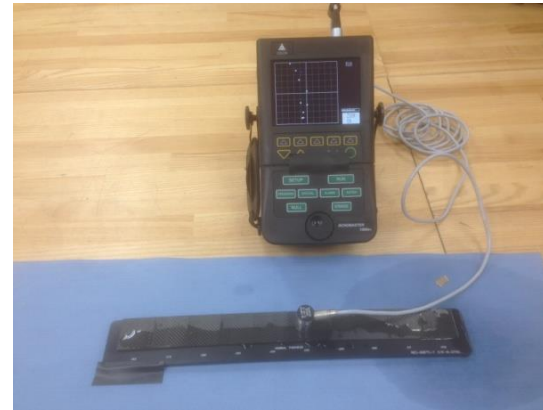
Discerning the difference in the ply thickness.
These screen captures show the resolution of the separation in plies.
The BMT resonance method clearly would be an easier interpretive skill.

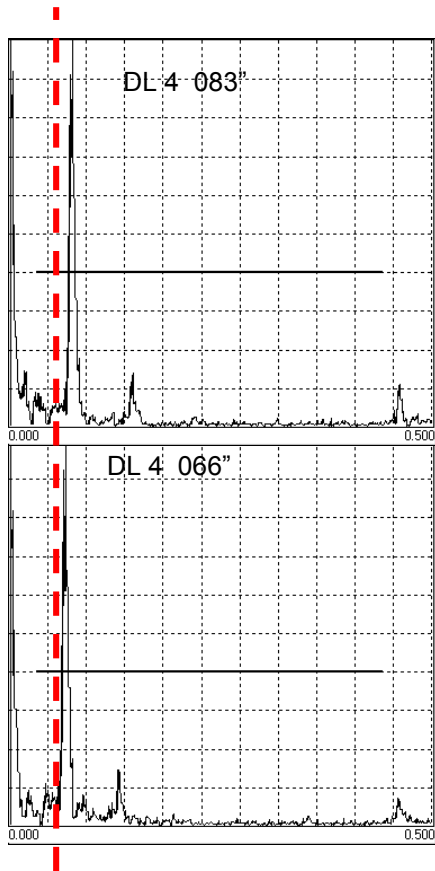
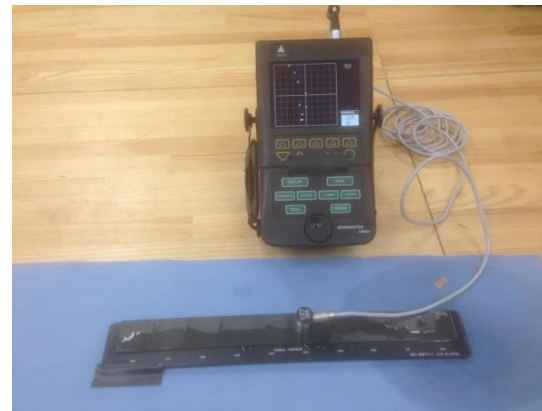
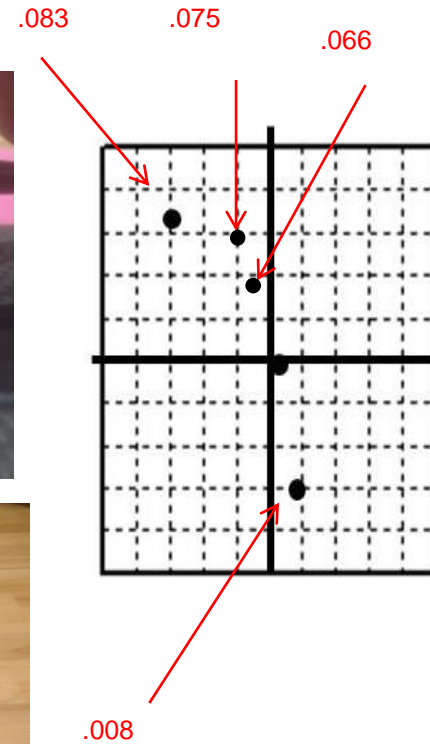
DL 4 066" DL 4 083"

Discerning the difference in the ply thickness.
These screen captures show the resolution of the separation in plies.
The BMT resonance method clearly would be an easier interpretive skill.

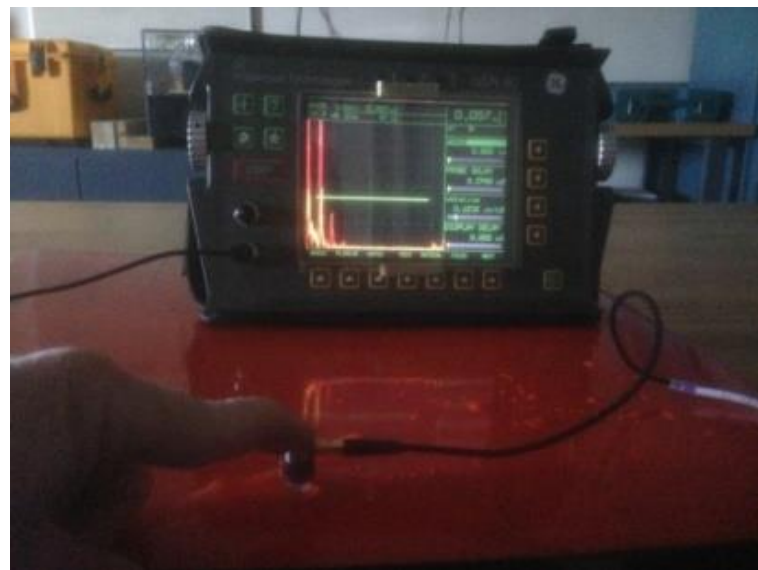
- Plies of bidirectional (quasi-isotropic) laminates can cause a loss of UT signals.
- This condition can be mistaken for internal structure damage of carbon fiber laminates, making difficult to properly interpret.

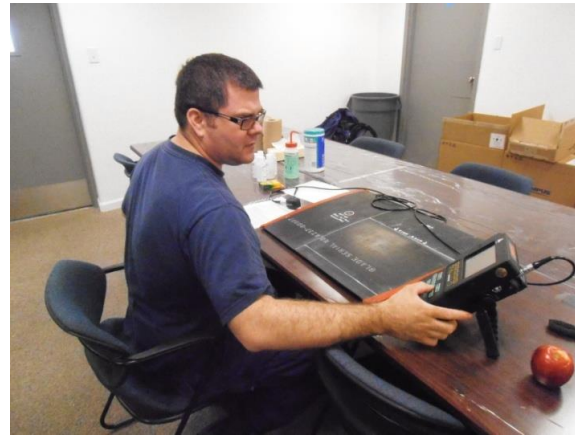
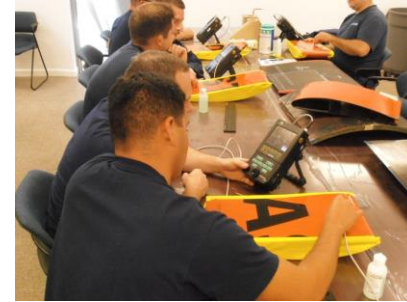
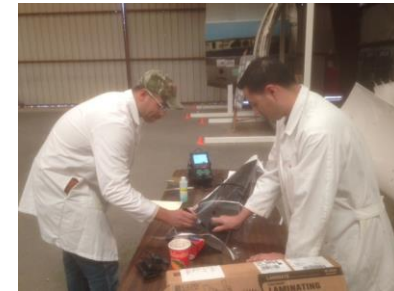
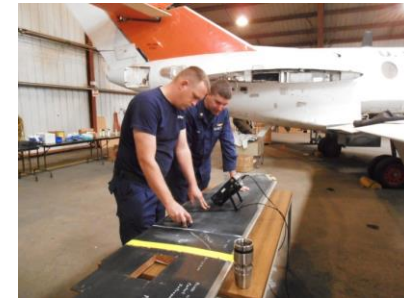
BS115
162 BS

12.0" inches

9.750" inches

Fiberglass over spar
Fiberglass/ Nomex structure

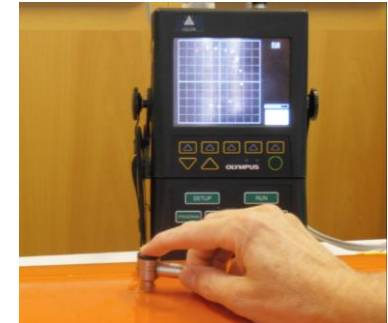
Delamination between stringer and skin

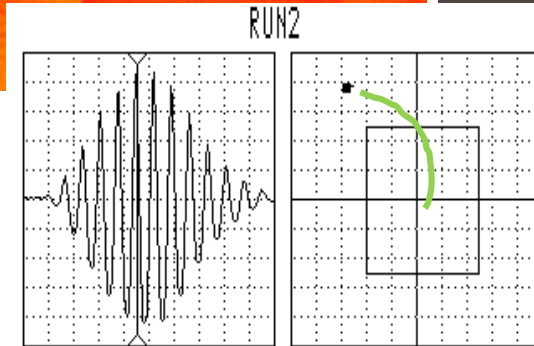
HC 144 Prop Blade
S/N : 2005040643 Convex
Side
Pre-Induced Defect

FIBERGLASS SKIN DELAMINATING FROM TRAILING EDGE TO
3 INCH UP BLADE, ENTIRE LENGTH OF BLADE ON
BOTH SIDES.

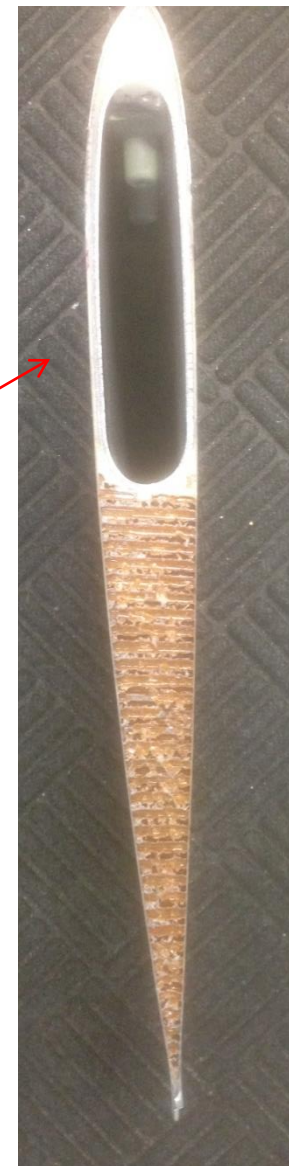
Spar

#1 MAIN ROTOR BLADE HAS ~~2 INCH~~ 2 INCH BY 3 FOOT VOID
RUNNING LENGTH WISE IN MIDDLE OF BLADE.
