# U.S. ARMY COMBAT CAPABILITIES DEVELOPMENT COMMAND – GROUND VEHICLE SYSTEMS CENTER

Long Term Tire Storage

05 FEB 2019

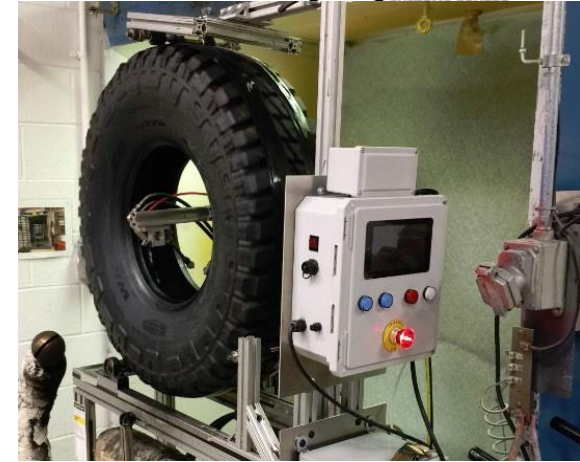
PPG Industries has developed a waterborne, protective coating for spray application to the interior and exterior sidewall tire surfaces.

- The coating is a barrier to oxygen and ozone and blocks the transmission of UV light to the tire rubber

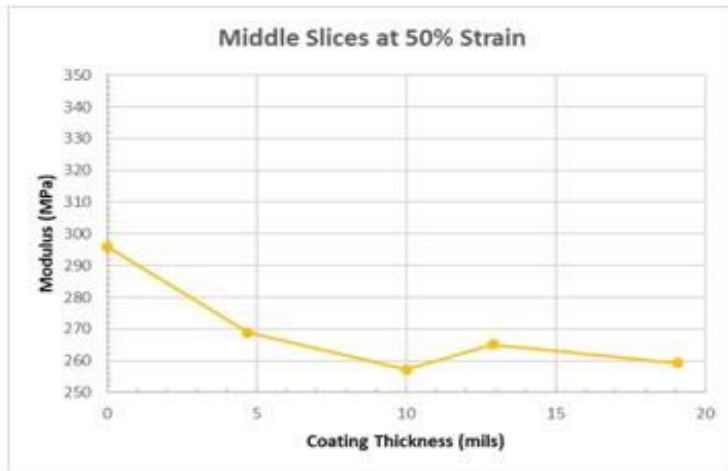
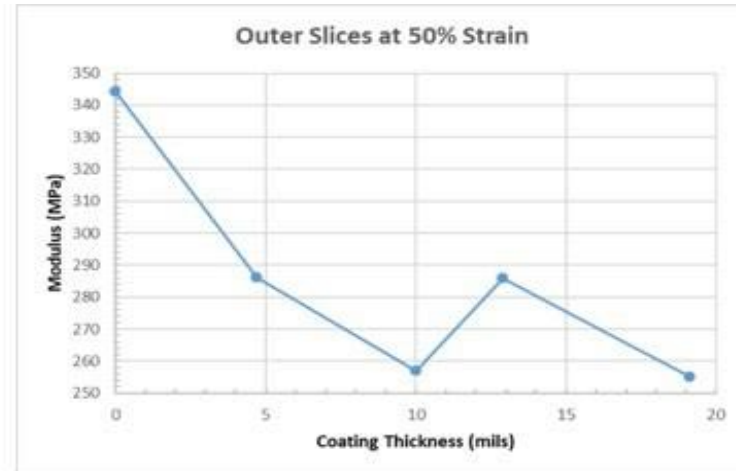
Heat Age Study: Evaluate coating thickness on tire aging properties

- Coat 1/2 inch thick rubber slabs
- Heat Age 10 days at 90 Deg C

Results show improvement in Modulus Values due to Age Hardening of coated tire versus non-coated tire

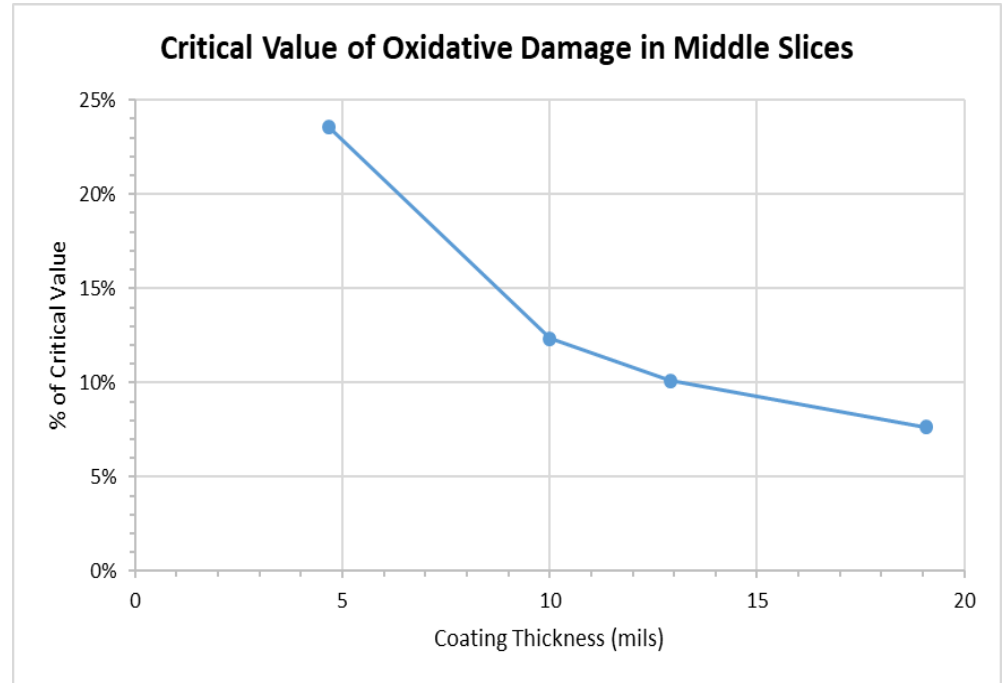
Evaluation shows improvement in oxidative aging and ozone resistance of coated tire versus a non-coated tire.
