The Use of Composites to Repair and Replace Damaged Metallic Ship Structures and Components

Composite Patch Repair of Cracked Aluminum Plates

Daniel Hart
NSWCCD, code 65

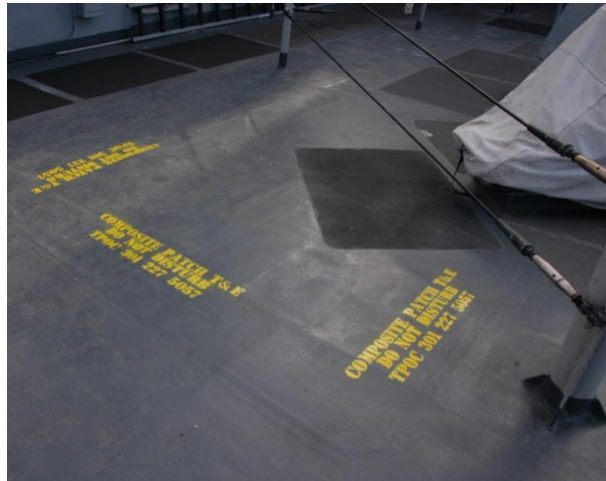
Composite Patches for Repair of Aluminum Ship Structure

- Installed to repair aluminum superstructure cracks
- Designed for in-situ application
 - Conforms to local deck profile
 - Low modulus reduces stress concentrations
- Surface preparation and edge treatment details critical
 - Details specific to aluminum for enhanced bond strength and durability
 - Reinforced sealant protects patch edge from moisture ingress and mechanical wear
- Quasi-isotropic E-glass and toughened-epoxy laminate
 - Wet layup with vacuum consolidation and hand layup around deck details
- T&E on-going
 - Development of analytical, design, and decision tools and repair material
 - Formulation of resin or adhesives to meet FS&T and strength requirements
- 5+ years of fleet performance to-date
 - Prototypes aboard 11 ships totaling more than 1,600 sqft of laminate
 - Initial repairs performed FY11

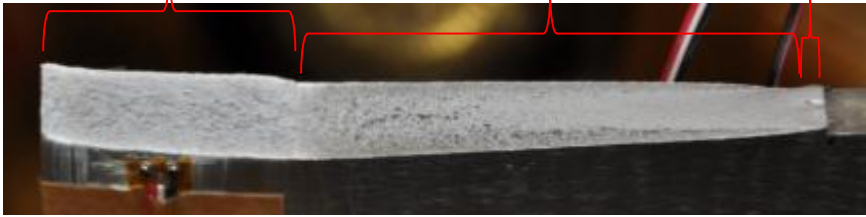
Far-Field Stress 5 ksi

- Load cycled $R=0.2$ (3 – 14 kips)
 - #16 Failure at $N=54,628$ (Aluminum)
 - No disbond around crack, only loaded 3,000 cycles past aluminum failure
 - #11 Failure at $N=284,300$ (Aluminum w/Patch)
 - No disbond around crack, only loaded 3,000 cycles past aluminum failure
 - #17 Failure at $N=234,800$ (Sensitized w/Patch)
 - 0.5 in. Disbond across crack plane, additional 51,000 cycles past aluminum failure

Ductile Fracture Slow Fatigue Fracture Fatigue Fracture

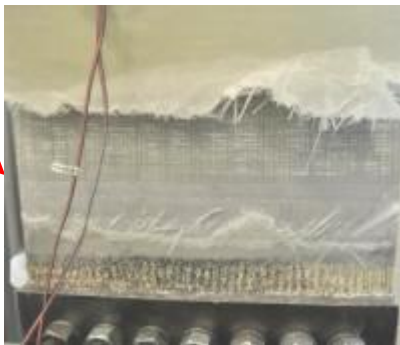
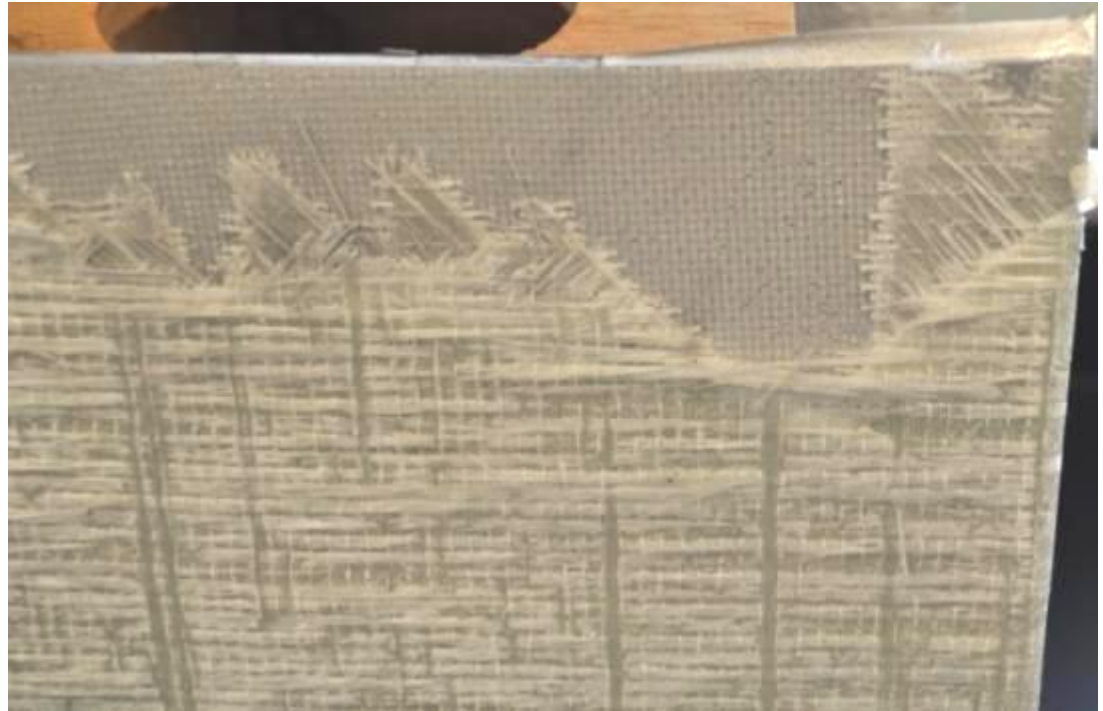
Far-Field Stress 14.5 ksi

- Load cycled $R=0.1$ (4 – 40 kips)
 - #14 Failure at $N=1,047$ (Aluminum)
 - #12 Failure at $N=16,390$ (Aluminum w/Patch)
 - Delamination and material failure 268 cycles after aluminum failure
 - #18 Failure at $N=12,517$ (Sensitized w/Patch)
 - Delamination started at aluminum failure and progressed for 364 cycles

Lower Laminate Plies Adhered to Lower Plate

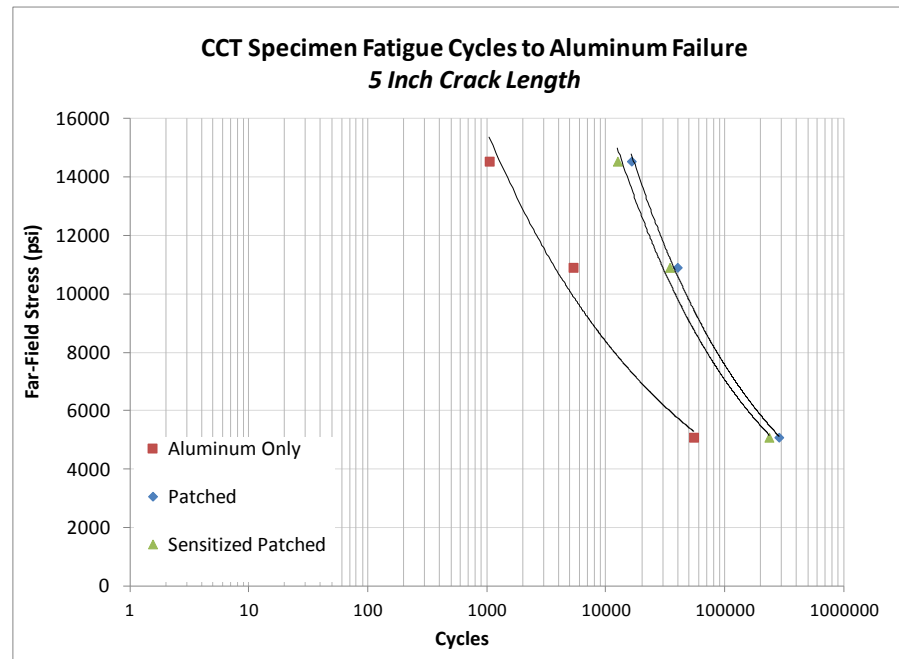
Fatigue Test Results

- Single specimen per case
- Composite patch repair increased fatigue life more than 4x
- Increased benefit of composite patch with increased stress level (4x, 6x, and 10x)
 - $\sigma = 5$ ksi, $R=0.2$, Patch increased fatigue life by more than 4x
 - Composite patch continued to carry load, testing was stopped
 - $\sigma = 10.9$ ksi, $R=0.1$, Patch increased fatigue life by more than 6x
 - Composite patch continued to carry load, testing was stopped
 - $\sigma = 14.5$ ksi, $R=0.1$, Patch increased fatigue life by more than 10x
 - Composite patch material failure and delamination immediately following aluminum failure
